Navajo Abandoned Uranium Mine Site Screen Report

Section 23 AUM Site

Navajo AUM Eastern Region

May 2009

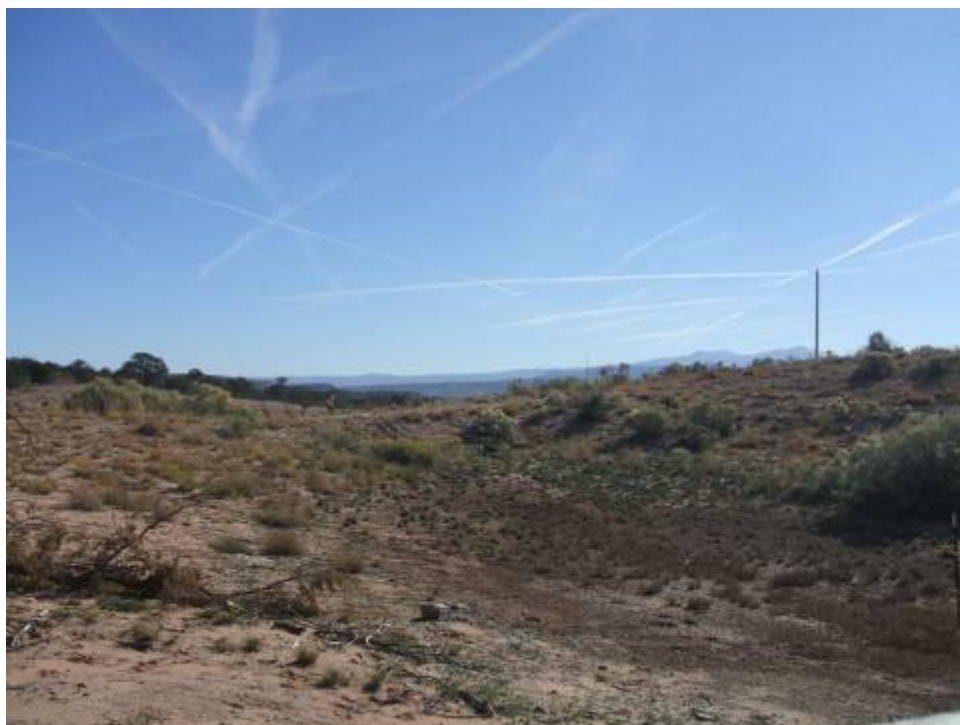
Photo 1. Section 23 mine site, eastern area, towards the east

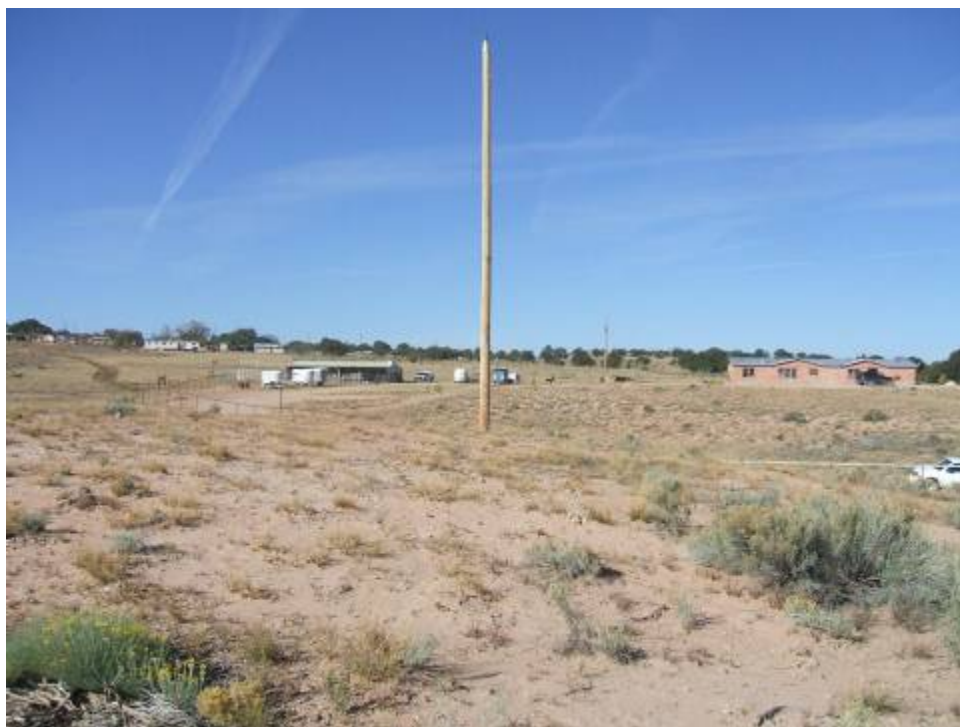
0 to 200 feet: 1 house is located within the north-central portion of the site. the house has been recently constructed, set on excavated cover material. Water is brought in from an outside source and stored in an underground poly-tank.

- The onsite house was measured at gamma radiation level upto 327,456 counts per minute (cpm)
- The levels near the trailer homes were found to be less than two-times background levels.

Photo 2. Section 23 mine site, house compound located onsite, towards the west

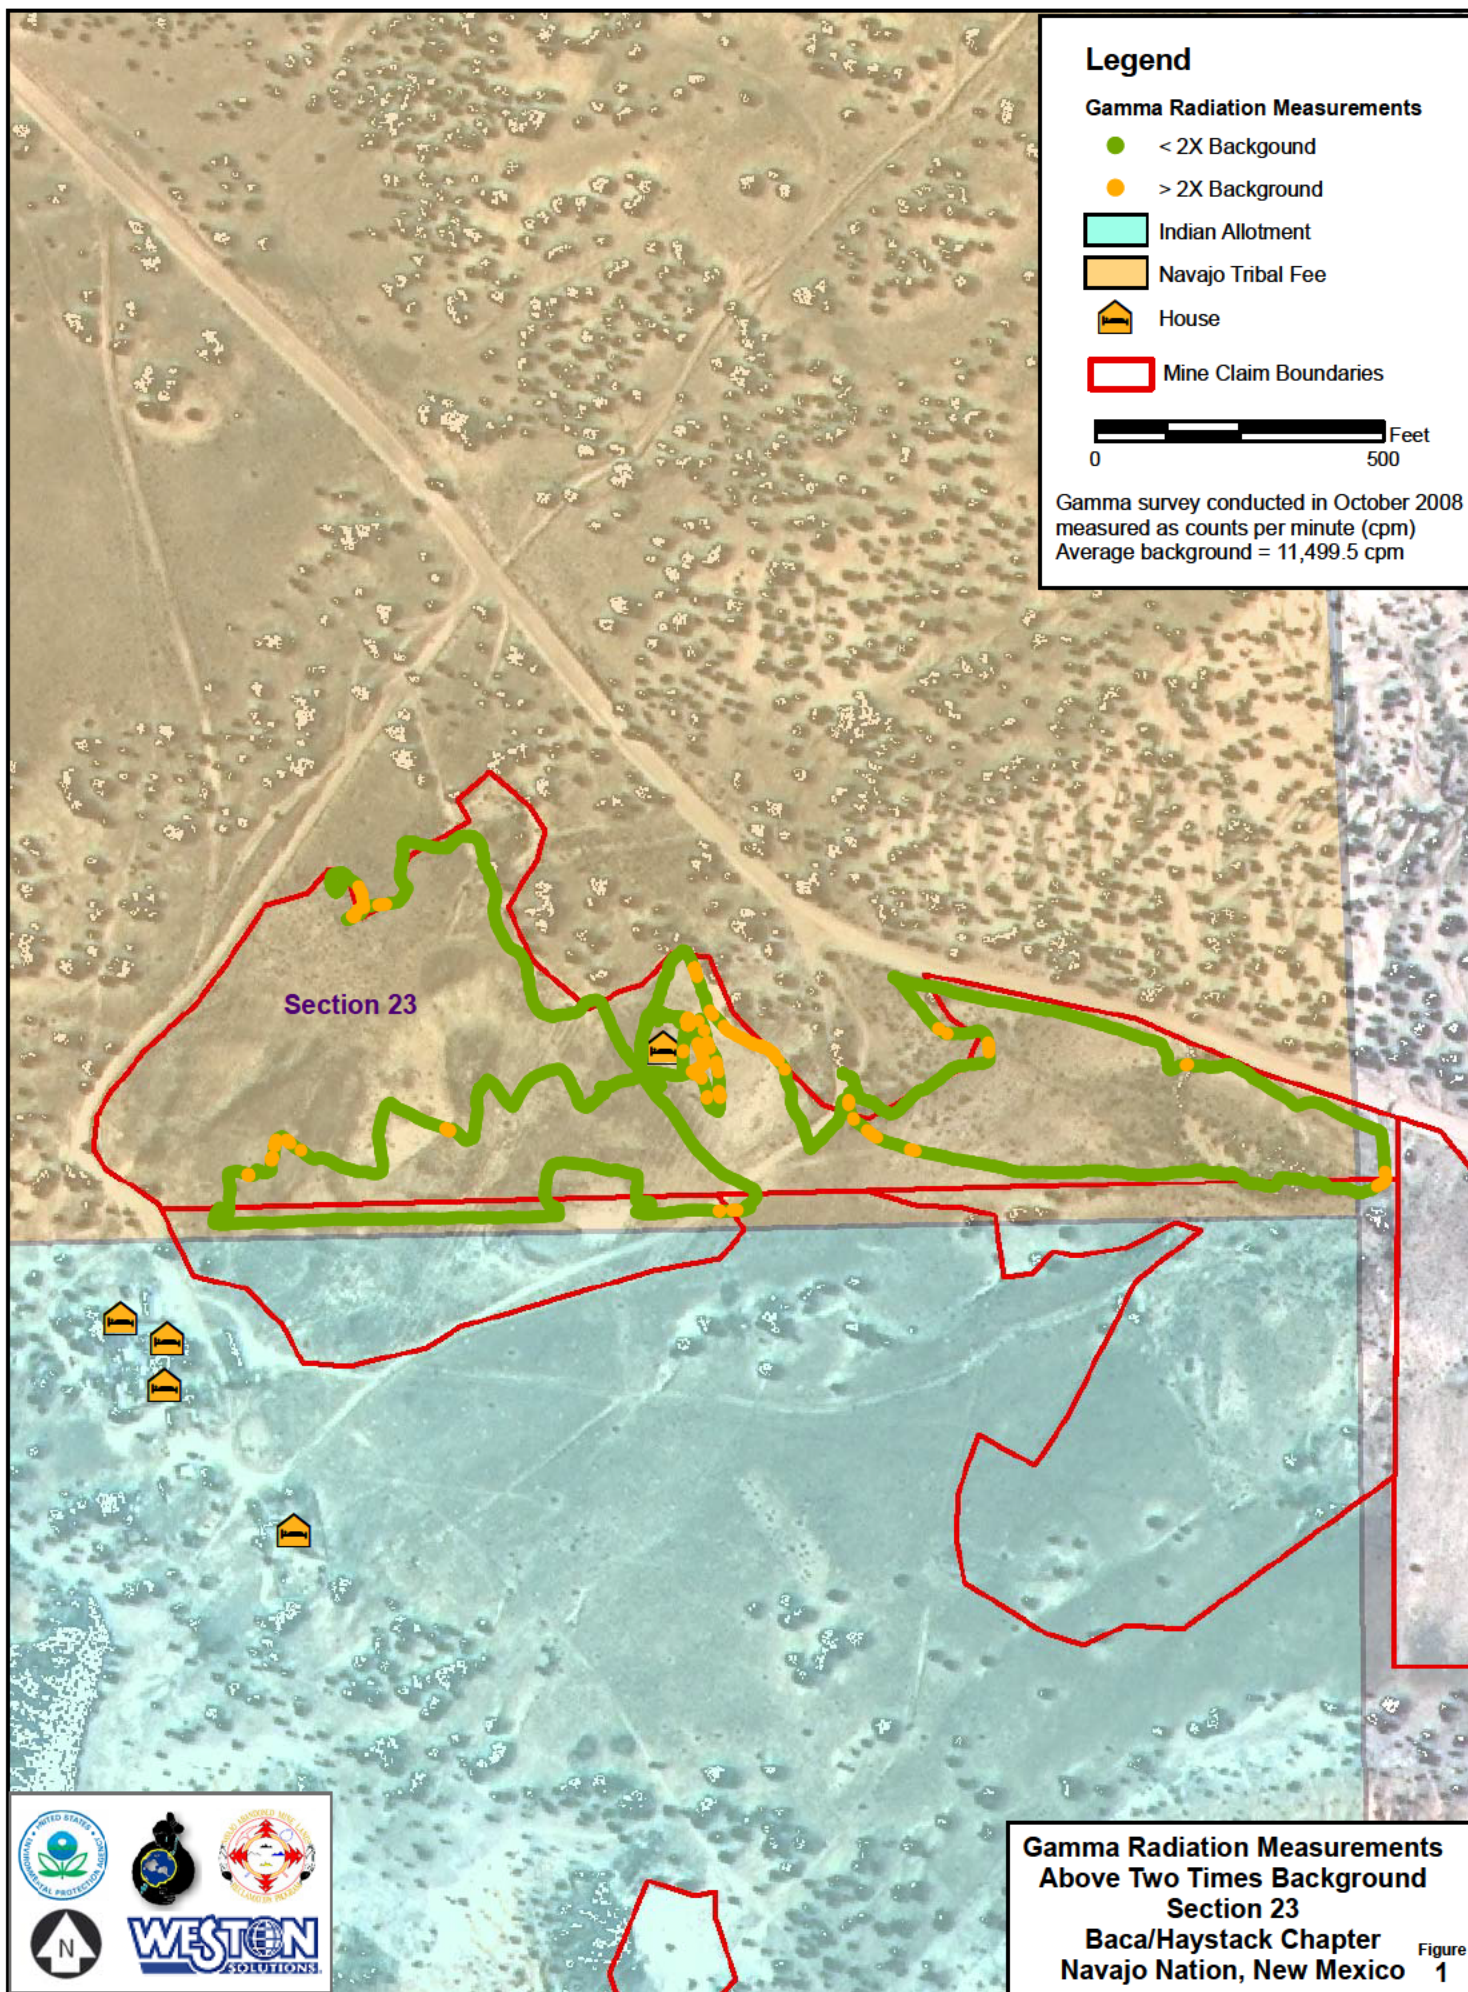
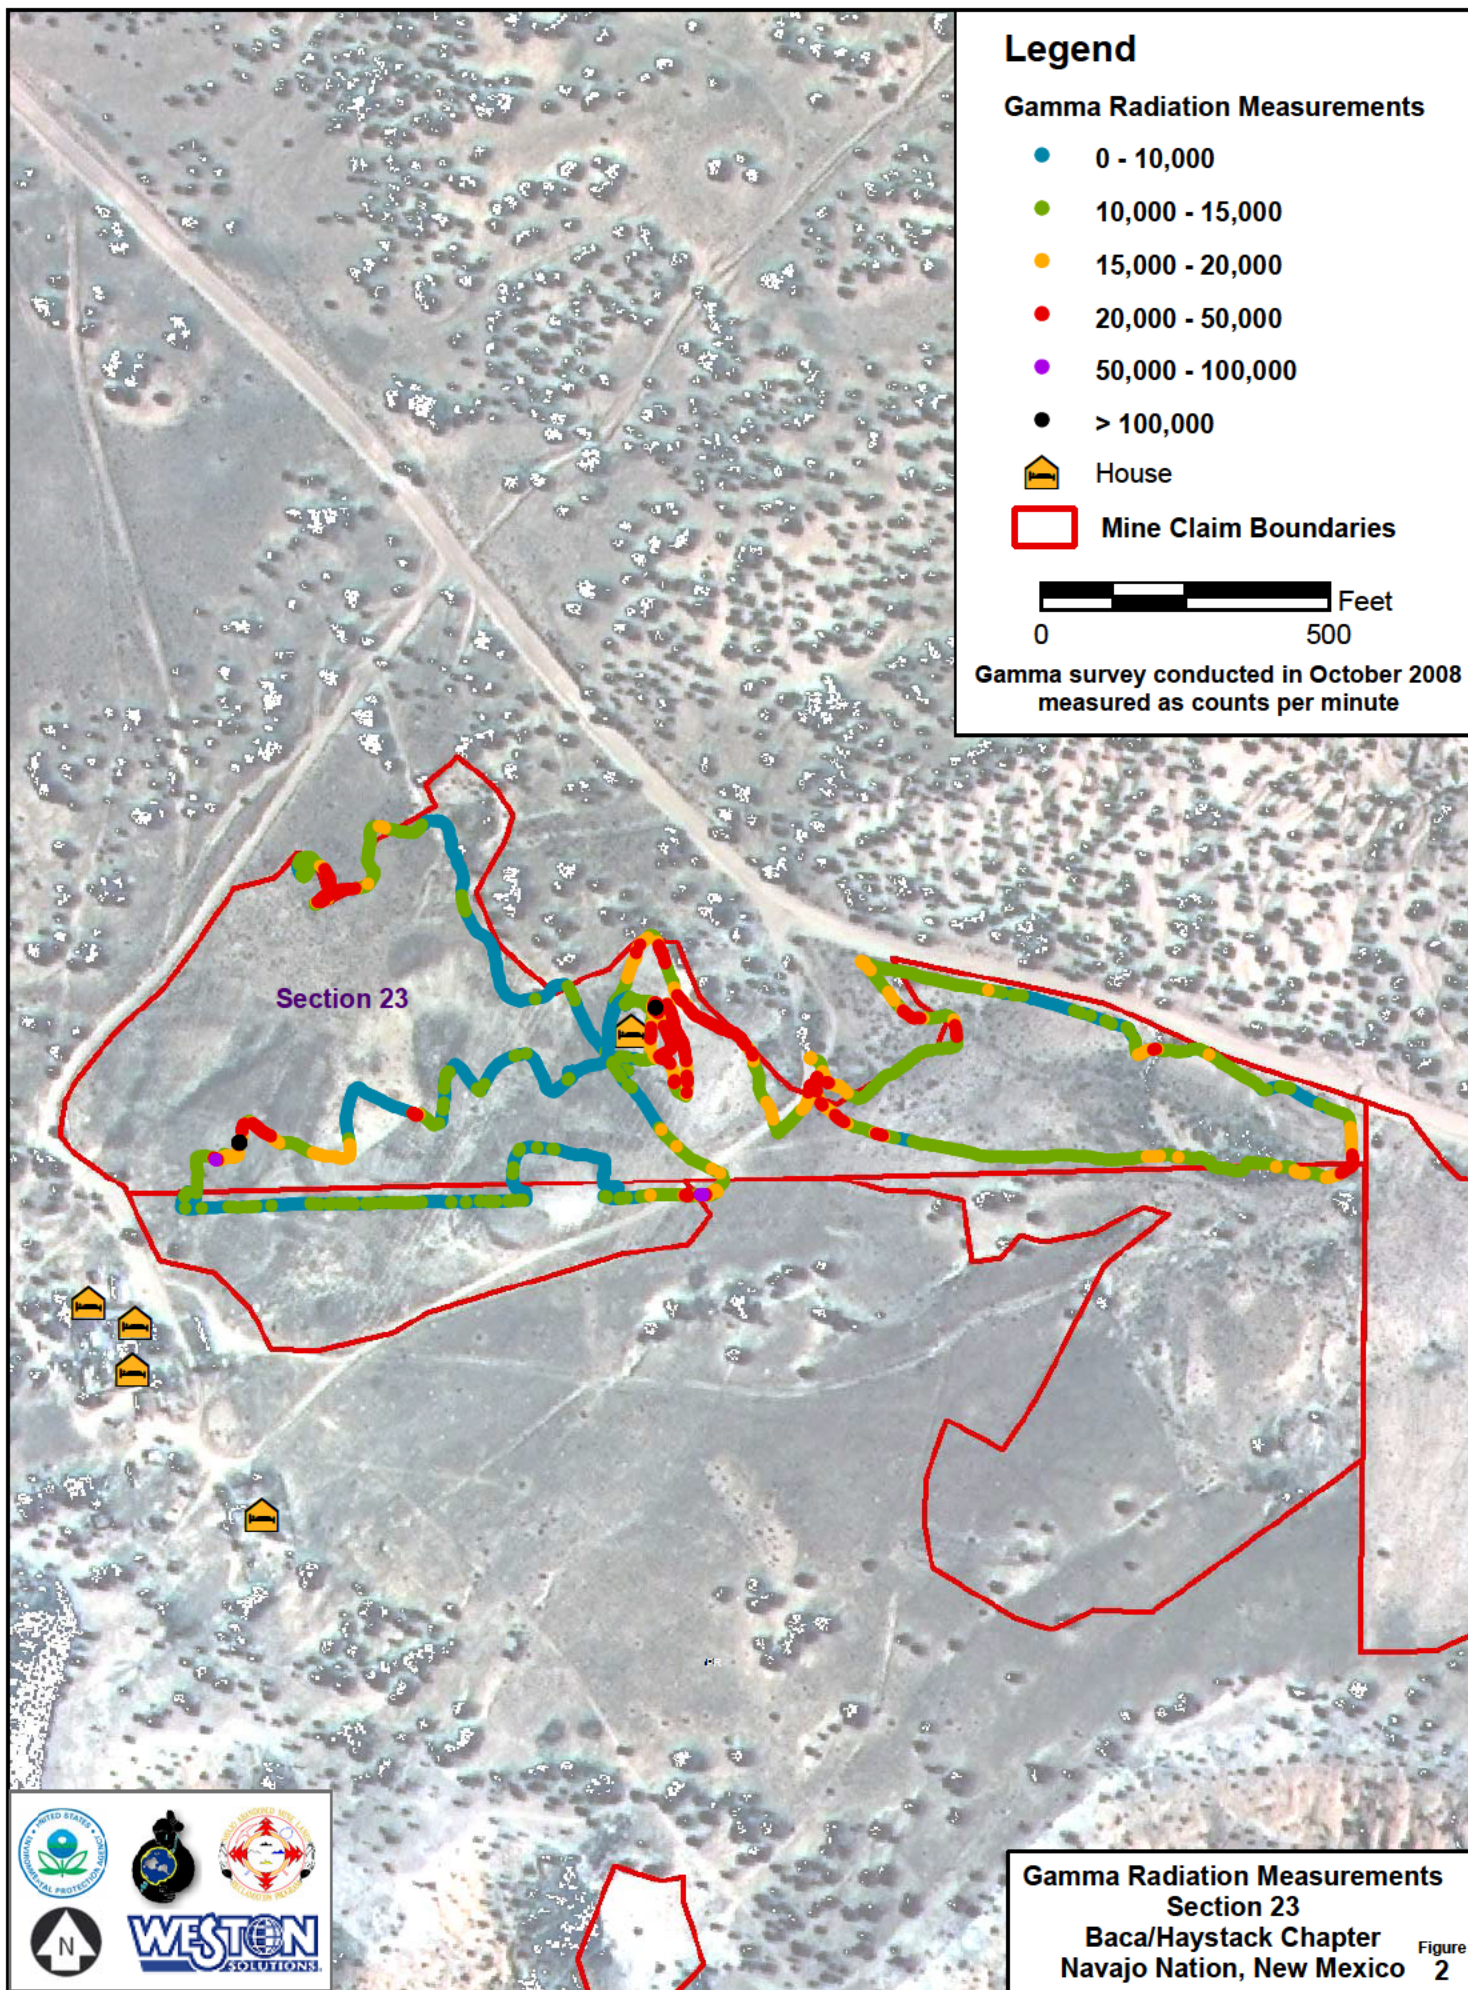
A total of 3,315 gamma radiation measurements were collected from mine sites, ranging from 5,802 cpm to 327,456 cpm. Measurements were found at their highest near the onsite house. The measurements are represented in Figures 1 and 2.
